SERVICE CALL 0380 [00"H3"0]

# SERVICE CALL 0380 ON TR2 CONVERSION

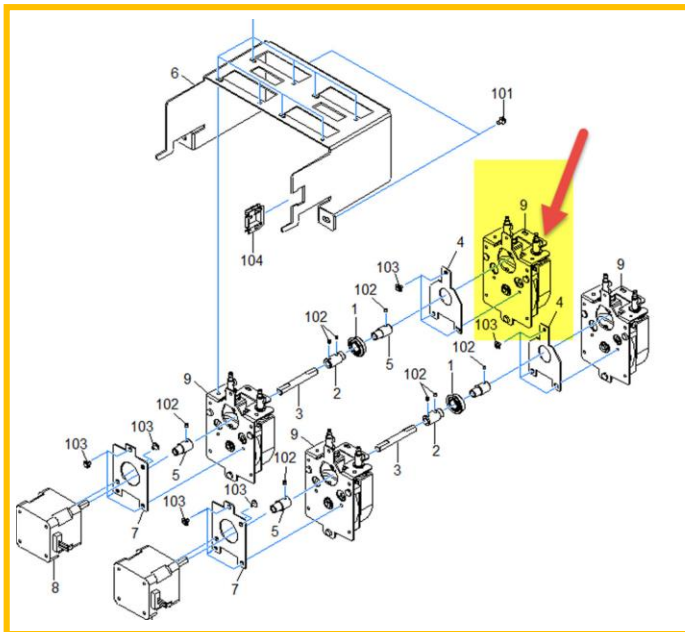
During pump up from cleaning bath from wiper Service Call 0380 [0020] or [0030] shows up in display.

No possibility to pass, even after to go back to FW 3.10 and to start all over again.  
The Service Call returns!!! We tried to do some cleanings.....without succes!

- Just by disconnecting the Captop 3 from the suction pump, you can tackle the issue.
- After you closes the “waste valve” please keep in mind to connect the Captop 3 on the Suction pump.
